Manhole Inspection Summary

Manhole # S27CC_016MH

Location Address: **1429 MYRTLE AVE**

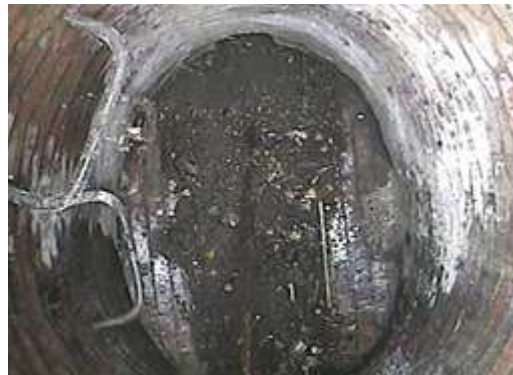
Defect 1

Count: **5** Missing: **0** ☒ **Corroded**

STEPS CORRODED

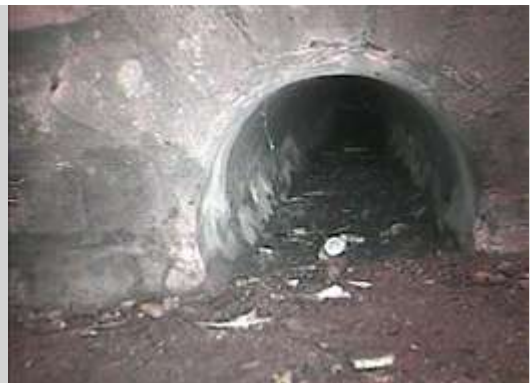
12 O'Clock Outflow

8 in. Circular Gravity Sewer
Pipe Out @ 12 O'Clock

Deposits: ☐ None ☐ Mud ☐ Sludge ☒ **Debris** ☐ Grease

Silt Depth: **1** (in.) Deposits Extent: **Light**
